## **MEMORANDUM**

Date: 1/14/2025 Job No.: 11267

Subject: July 16<sup>th</sup> Outfall Screening

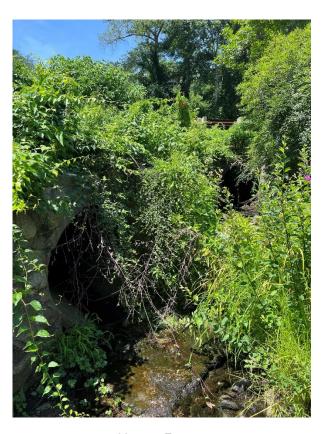
N-285, Far away

0.25 mg/L of surfactants is a concentration commonly found in groundwater, and both results from the laboratory tests are well below the allowable thresholds. None of these readings are indicative of any illicit discharge or connection. Based on these readings BETA believed the continued observed flow was likely from an inlet, and upon further investigation this was confirmed with the source being a small stream to the south of the outfall along River Street.
